Licensee Event Report 2008-007-00

PILGRIM NUCLEAR POWER STATION

Momentary Loss of all 345kv Off-Site Power to the Startup Transformer from Switchyard Breaker Fault

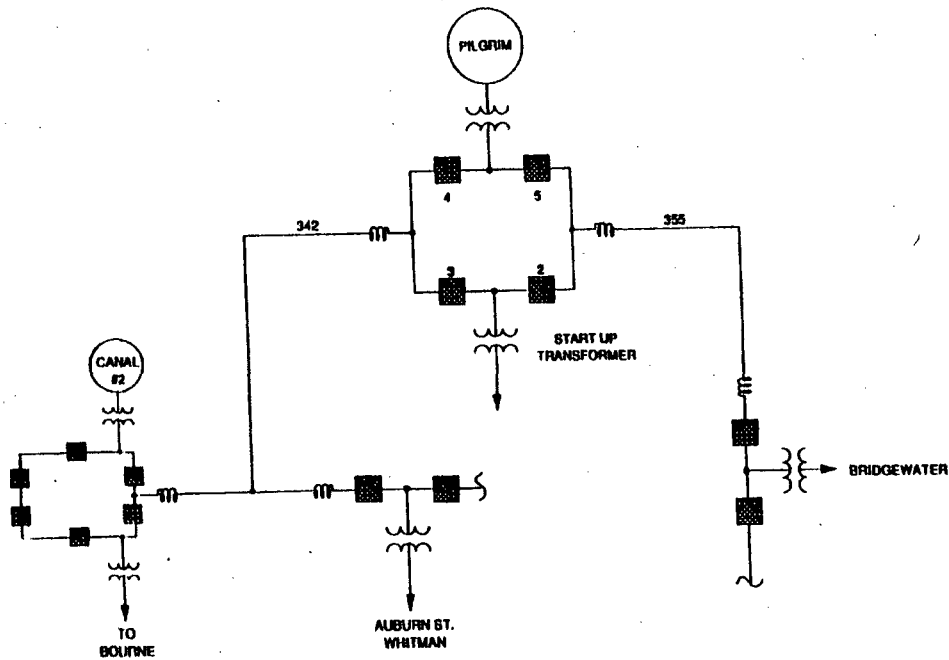
Line 355 is a two terminal line which connects Pilgrim to NGRID's Bridgewater Station and is connected to ACB-102 and ACB-105. Line 342 is a three terminal line, which connects Pilgrim to the Canal Power Plant's Switchyard in Sandwich, MA and to Auburn Street Station Switchyard in Whitman, MA. The Canal Switchyard is owned and operated by NSTAR and Auburn Street Station Switchyard is owned and operated by NGRID. Pilgrim's ACB-103 and ACB-104 connect Line 342 to the plant's switchyard. The 345kv system is the Pilgrim Station output power connection and also is the preferred off-site source via the SUT. See attached sketch for switchyard breaker arrangement. (The ACB's are identified by their last digit only).

On December 20, 2008 at 1045 hours, a flashover of a phase B arc horn on the Line 355 bus section occurred due to accumulated snow falling from the overhead bus and bridging the gap to the arc horn. (This is the Direct Cause of this event.) In response to this, ACB-102 opened per design, but ACB-103 opened in response to a transfer trip signal from the Auburn Street Station, which is associated with Line 342. Since the fault was not on Line 342, Auburn Street Station should not have sent this transfer trip signal. The tripping of the ACB-102 and ACB-103 resulted in a loss of the SUT supply and transferring of Pilgrim's safety busses to the EDGs. Subsequently, Lines 342 and 355 re-energized, ACB-102 and ACB-103 auto reclosed, and remained closed per design.

The root cause of this event was an inadequate DGOR setting on the Auburn Street Station Line 342. This relay initiated a Line 342 transfer trip signal to open ACB-103 which resulted in the momentary loss of the SUT. The initiating event was a flashover of a Phase B arc horn on the Line 355 bus section due to accumulated snow falling from the overhead bus and bridging the gap to the arc horn, causing ACB-102 to trip per design; ACB-103 opened shortly after in response to a transfer trip signal from the Auburn Street Station. The tripping of the ACB-102 and ACB-103 resulted in a loss of the SUT supply and transferring of Pilgrim's safety busses to the EDGs.
